# Manhole Inspection Summary

Manhole # S45SS\_003MH

Insp Date: **2/8/07 1:54 PM**

**Location** Address: **2728 HARFORD RD**

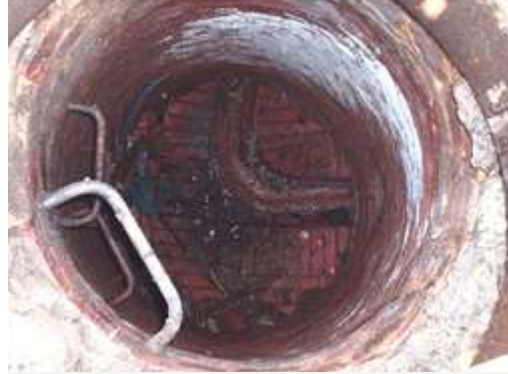
Top View

Corroded steps. Bench debris.

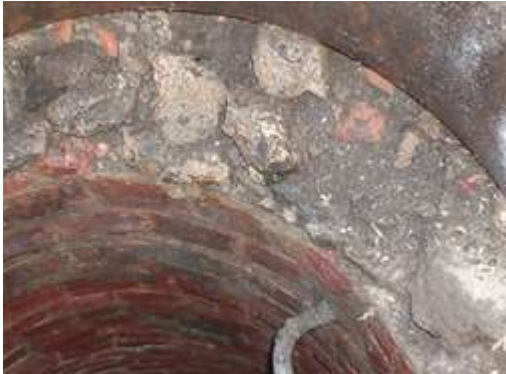
Defect

Frame leaks. Frame offset. Adjustment deterioration and infiltration.

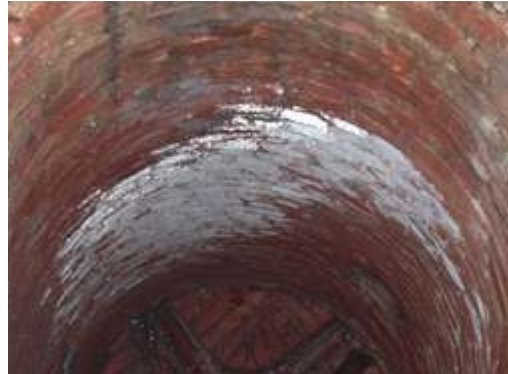
Defect

Adjustment, Corbel and Barrel infiltration.

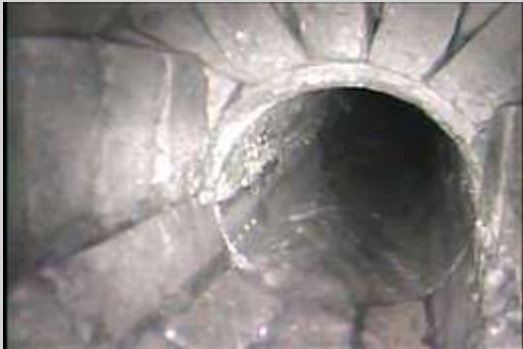
Pipe Out @ 12 O'Clock

Deposits: ☐ None ☐ Mud ☐ Sludge ☐ Debris ☒ **Grease**

Silt Depth: **0** (in.) Deposits Extent: **Light**

Infiltration: **None** Pipe Seal Cond: **Unknown**

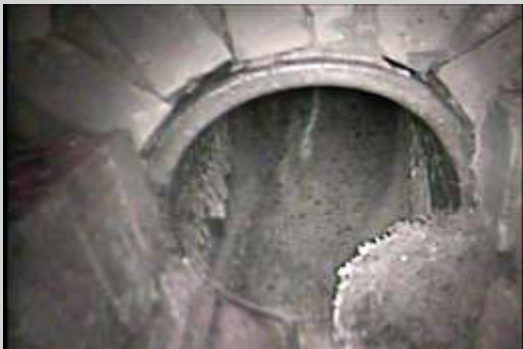
Pipe In @ 3 O'Clock

Deposits: ☐ None ☐ Mud ☐ Sludge ☐ Debris ☒ **Grease**

Silt Depth: **0** (in.) Deposits Extent: **Light**

Infiltration: **None** Pipe Seal Cond: **Roots**
